JOURNAL OF GREEN SCIENCE AND TECHNOLOGY

ROAD SURFACE ANALYSIS USING THE INTERNATIONAL ROUGHNESS INDEX AND PAVEMENT CONDITION INDEX (CASE STUDY: Gajah Mada Street, Tegal City)

**Riza Phahlevi Marwanto¹, Andhika Adiwidya Maheswara¹, Damar Risky Bahrelsi¹, Brezinka
Ayu Perdana¹, Ina Fitria¹, Suprpto Hadi¹**

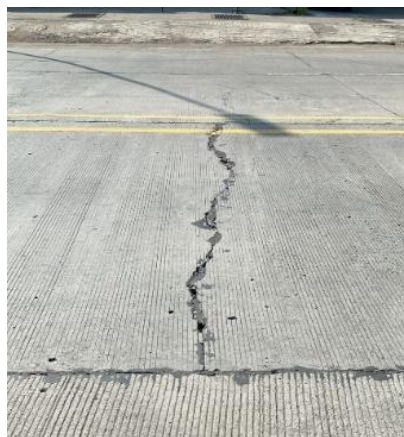
Figure 4. Linear Cracking Damage

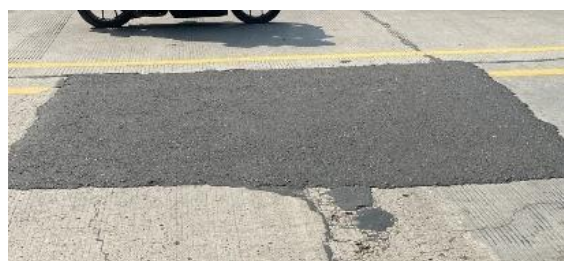
Figure 5. Patching Damage

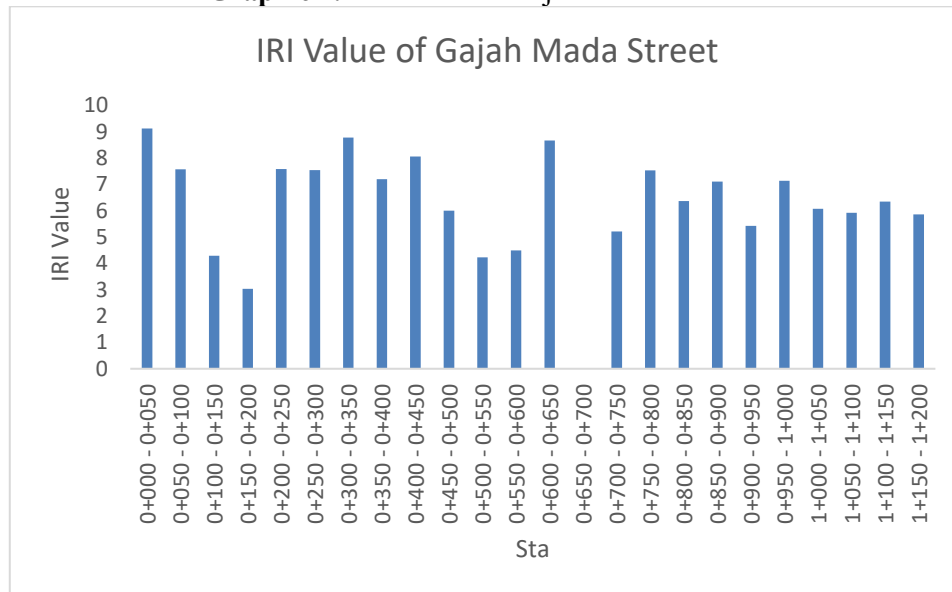
Graphic 1. IRI Value Of Gajah Mada Street

Road surface conditions based on The International Roughness Index (IRI) values are classified into four categories. If the IRI value is less than or equal to 4 m/km, the road is in good condition. Values between 4,1 and 8 m/km indicate fair condition. A road is categorized as bad if the IRI value is in the range of 8,1 to 12 m/km, while an IRI value exceeding 12 m/km indicates a poor condition[15]. From the table above, the IRI value on Gajah Mada Street is 6.23 m/km which is included in the fair category. The result of the research on Gajah Mada Street in Tegal City showed that the average PCI value was 77, with a very good category. Meanwhile, the average *International Roughness Index* (IRI) value was 6.23 m/km, which was categorized as fair condition. On the other hand, the traffic volume on this road is relatively high, amounting to 7,160 55 smp/hour in lane 1 and 5,919,55 smp/hour in lane 2, with the dominance of two-wheeled vehicles. The Gajah Mada road pavement uses rigid pavement. Rigid pavement is a pavement structure formed from a concrete mixture, consisting of cement, sand, and coarse aggregates such as crushed stone, which can be reinforced with steel reinforcement or not, depending on design needs. In general, this pavement consists of subgrade, subbase, and Portland cement concrete slab with or without reinforcement.[16]. Concrete pavement was chosen because the road is traversed by vehicles with large loads and high traffic volumes[17]. This type of pavement has advantages over flexible pavement because rigid pavement can distribute the load over a large area of the subgrade[17]. In addition, rigid pavement is more resistant to heavy loads and has a longer road life than flexible pavement[18].

The difference between PCI and IRI values indicates that road surface unevenness (IRI) is more sensitive to the effects of high traffic loads than visual surface deterioration (PCI). Some road segment, such as at stationing 0+000 – 0+100 and stationing 0+400 – 0+500, show high IRI values (>8 m/km) although the PCI values in these segment are still classified as good to fair. This indicates that the road is still visually good, but is beginning to experience comfort issues due to vibration or unevenness, which are not immediately apparent from visual inspection. It also shows that although there is not much severe visual damage, the road surface has undergone deformations that can impair driving comfort.

The high IRI values in some segments may be caused by small deformations, uneven concrete joints, or patches that have begun to bump, which are common characteristics of early deterioration of concrete pavement under high traffic loads. The amount of pressure from daily traffic, including heavy vehicles, is one of the main factors for these deformation. Increased traffic loads lead to an increase in IRI values, resulting in a reduction in the planned life of the road and increased road maintenance costs.[20]. Road damage due to excessive load on the road can occur because the growth of vehicles is higher than the growth of the road[21]. High traffic volumes accelerate surface deterioration in the form of roughness (IRI) before visual damage (PCI) becomes severe. This reinforces that concrete pavements, although structurally sound, still need to be monitored regularly especially in the context of high traffic volumes. Therefore, the recommended treatment is routine/periodic road maintenance, so that their function in serving user need can be optimally maintained[22]. Additionally, recommended technical measures include light grinding (profiling) to reduce unevenness and local patching in areas of minor damage. Overlaying is not necessary at this stage because no major structural damage was found. Routine and periodic maintenance remains the primary step in maintaining road performance and long-term service life. Routine and periodic road maintenance activities aim to ensure user safety and comfort and maintain the structural durability of the road until it reaches its planned life and supports mobility[23]. In addition, maintenance is also carried out so that road infrastructure is still able to accommodate the growth in traffic volumes during the planned service period.
